## **Guildford**

### **7. Guildford**

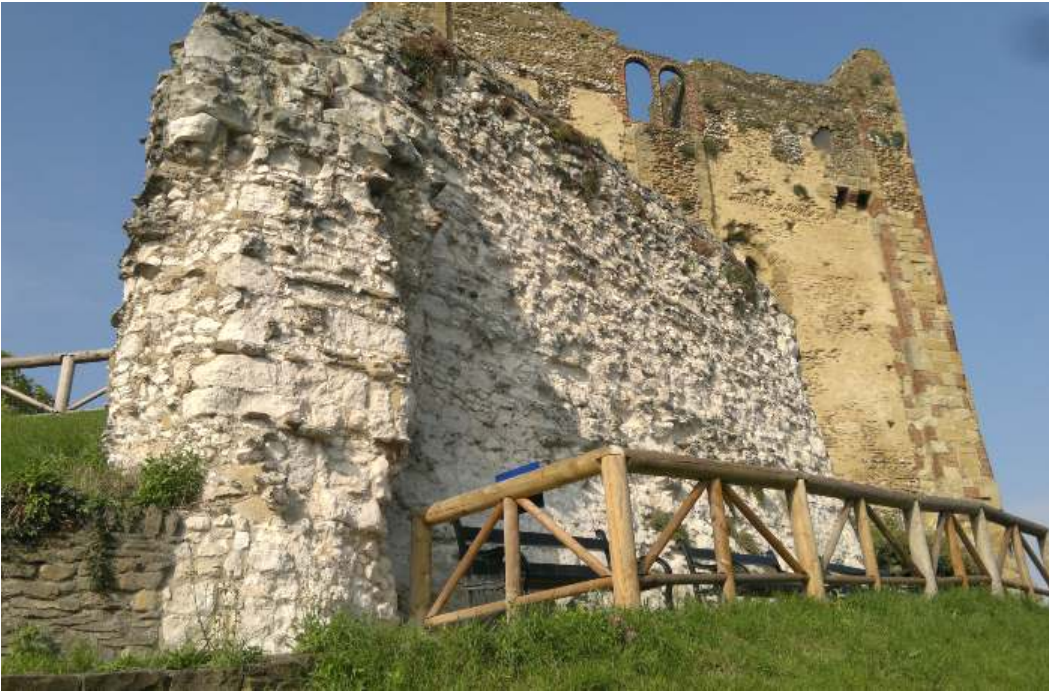
*Fig. 1. Guildford Castle shell wall and keep, from the south. The shell is built of local chalk but the keep of Bargate stone. The image 'Guildford Castle (2)' is by Richard Nevell. Licensed under CC BY-SA 3.0 via Wikimedia Commons. Reproduced with thanks.*

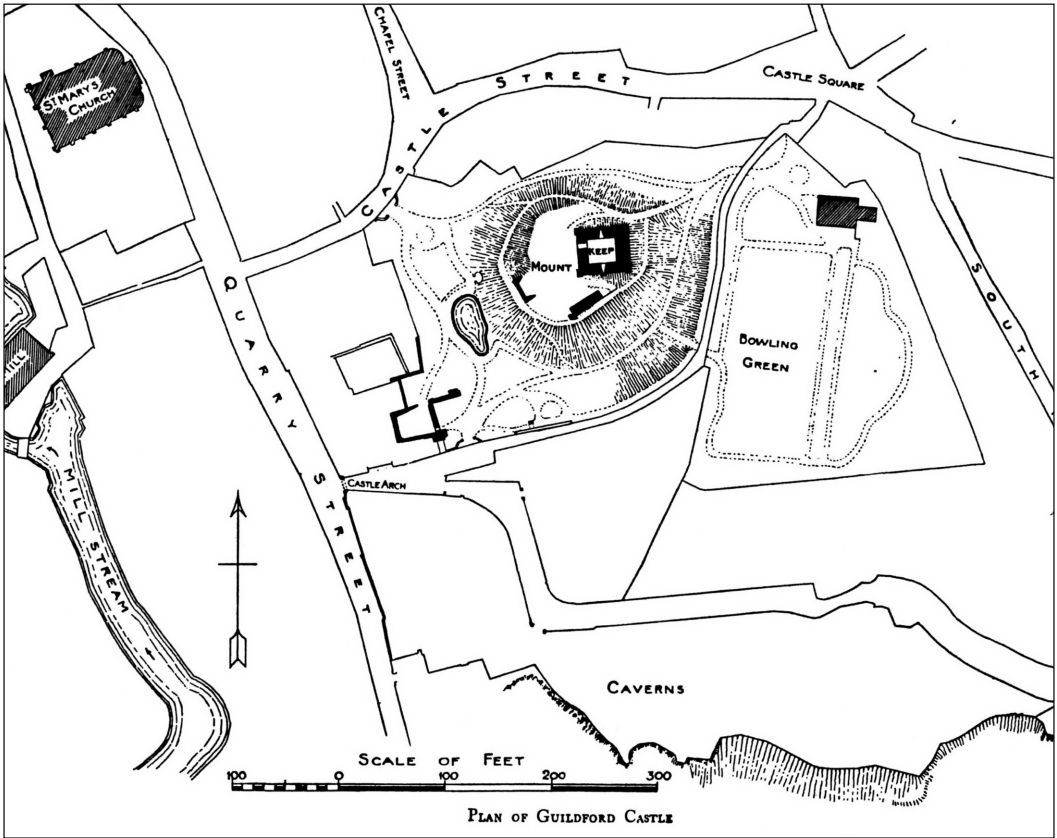
Fig. 2. Guildford Castle plan. From *VCH Surrey, Vol, III, 1911*. The motte is probably 11th century. The shell walls early-mid 12th century.

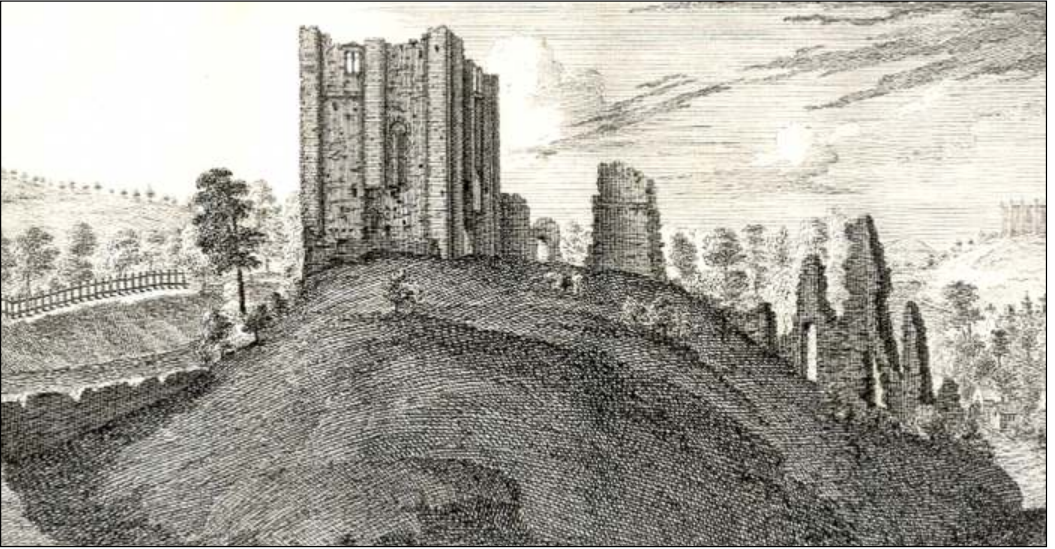
ABOVE: Fig. 3. Samuel & Nathaniel Buck, *Guildford Castle for the north-west*, 1737 (detail). In the largest chunk of masonry to the right of the keep there appears to be an inside ledge (or wall-walk?) along part of the interior shell wall. The shell-keep probably dates to the reign of Henry I, (1100-1135), heightened later.

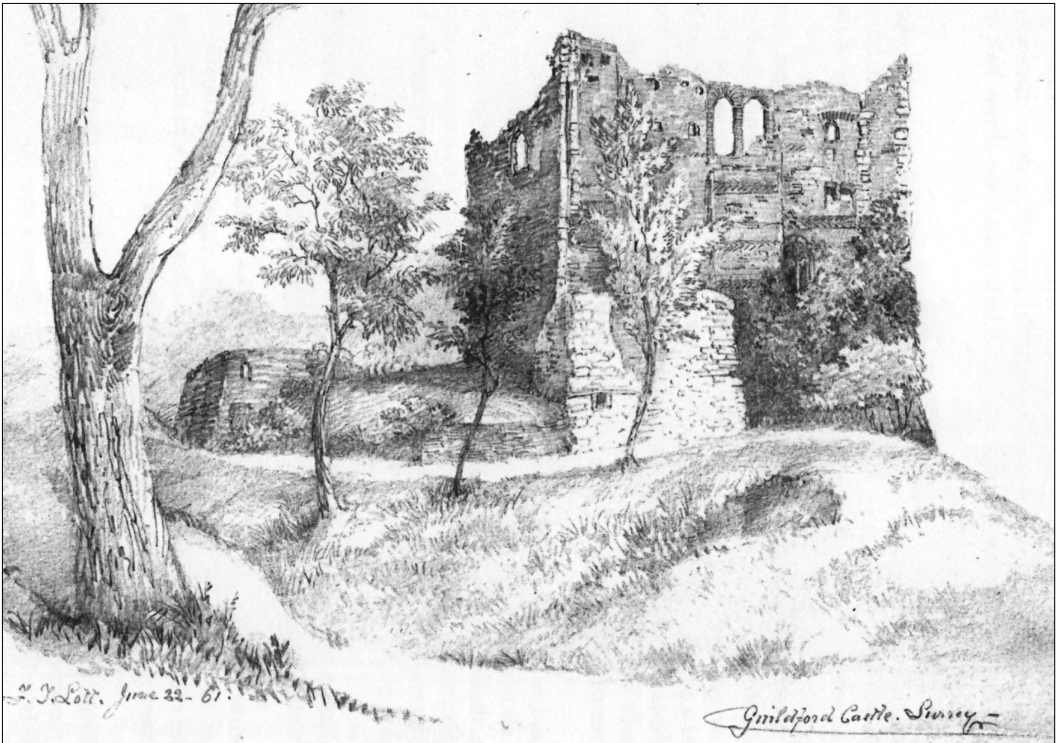
BELOW: Fig. 4. Drawing of the motte with its buildings in 1861 by F. T. Lott, showing some remaining parts of the shell wall. Looking toward the shell keep from the south. In front of the keep there is perhaps a latrine chute just below a string course (not seen on fig. 1). Courtesy of Guildford Museum, (Catalogue no. G.7785).

(Alexander 2006, 20, 27) (fig. 4) perhaps now represented by a fragment of projecting wall and perhaps also the location of the garderobes observed in the late 19th century (which no longer survive). The two straight stretches of wall now surviving suggest this putative shell-keep was of polygonal plan. The wall was built to encase the upper eleven-twelve feet of the motte, and not, as is more usual, on its summit. This may hint at an evolution of the site which is more complex than the above-ground evidence reveals. The motte seems to have been created largely out of the natural topography: perhaps the shell-wall retained the uppermost parts which were man-made?

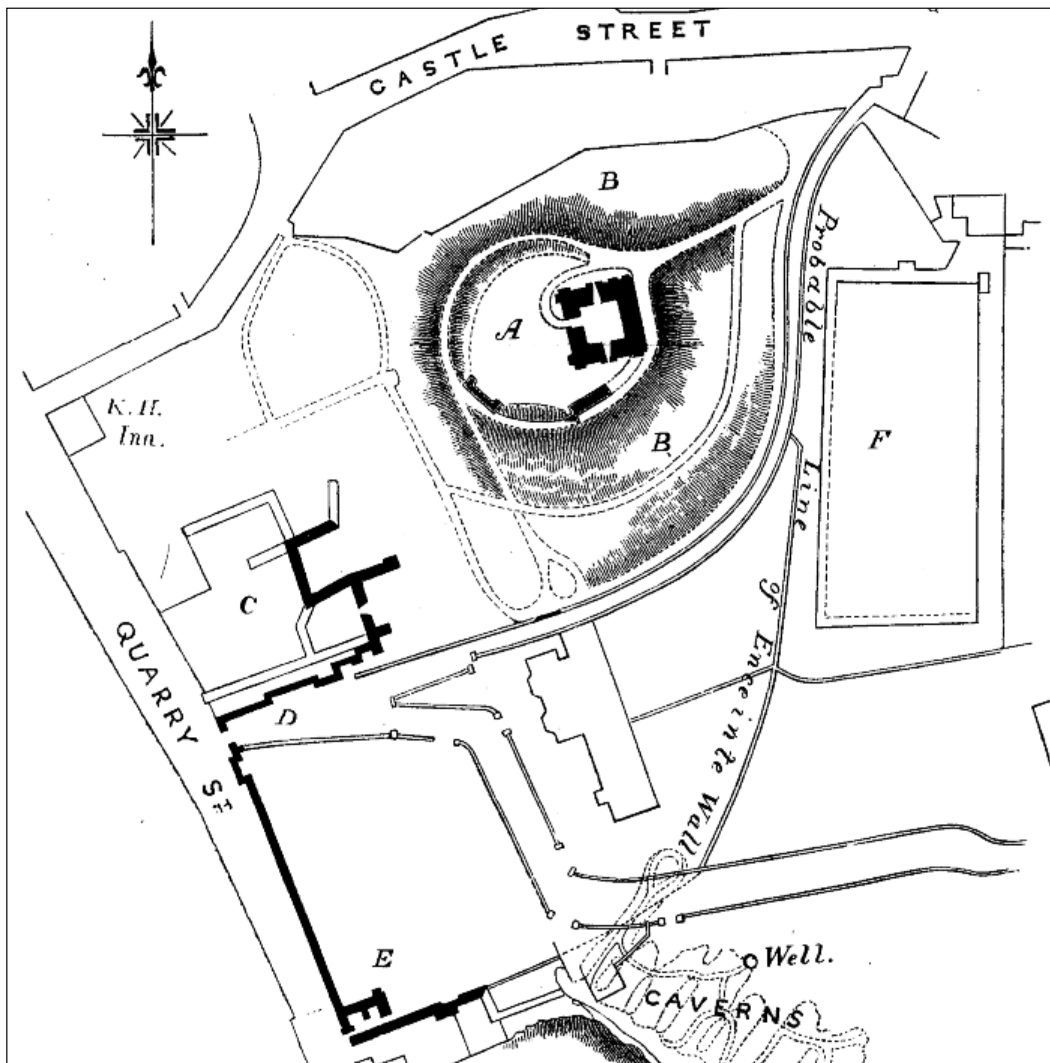
ABOVE: Fig. 5. Guildford castle plan from G T Clark, 1884. The A-F keys are not mentioned in his entry (Vol. II). The plan shows two significant sections of shell wall masonry.

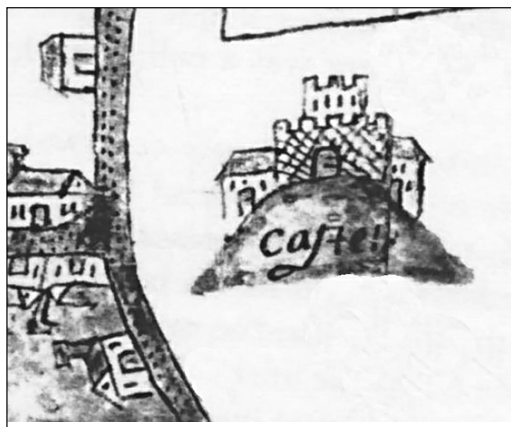
LEFT: Fig. 6. Illustration of the castle keep on a town map of c. 1600, (detail) with representative buildings on either side. Surrey History Centre, by permission of Lt-Col. Godwin-Austen. The whole sketch of the castle may be representational. The full illustration is in Alexander, 2006, p. 27.

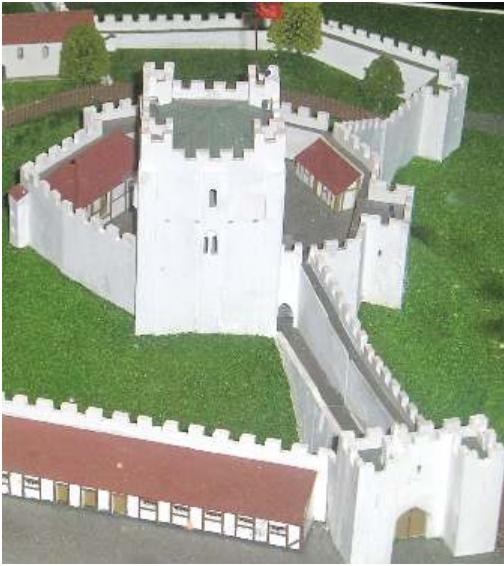
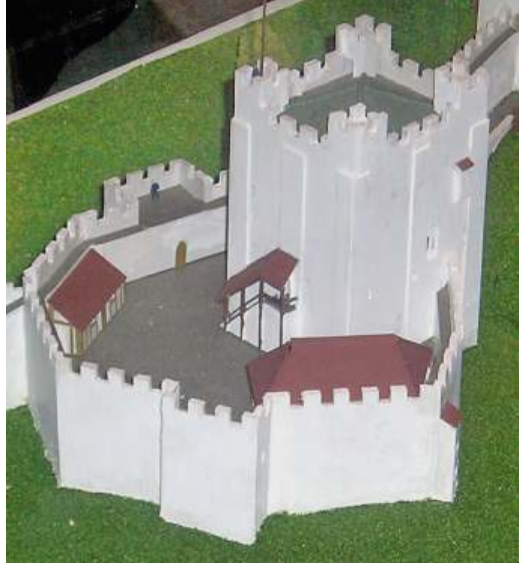
ABOVE: Left: Fig. 7 Guildford. On-site model, in the keep, of the shell keep and entrance from the east. Right: Fig. 8. Shell keep & tower from the west.

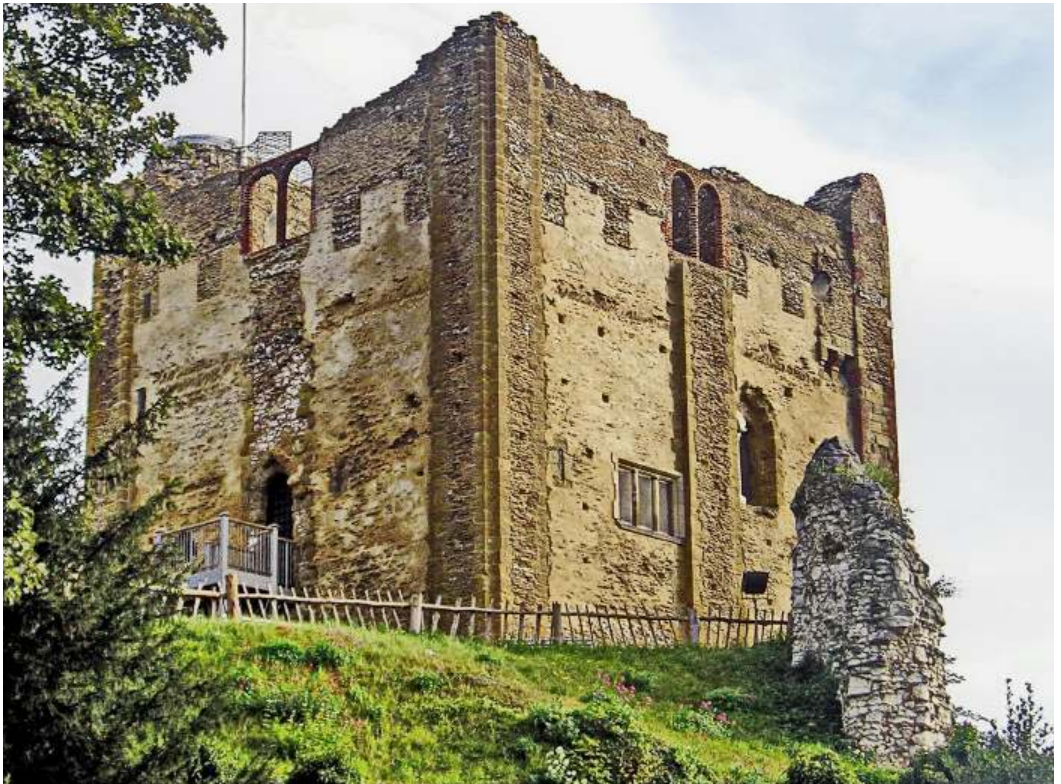
BELOW: Fig. 9. Fragment of the shell wall, (buttress or turret), and rectangular keep to rear, from the south-west (cf. fig. 1). The shell wall fragment appears to partly revet the motte.

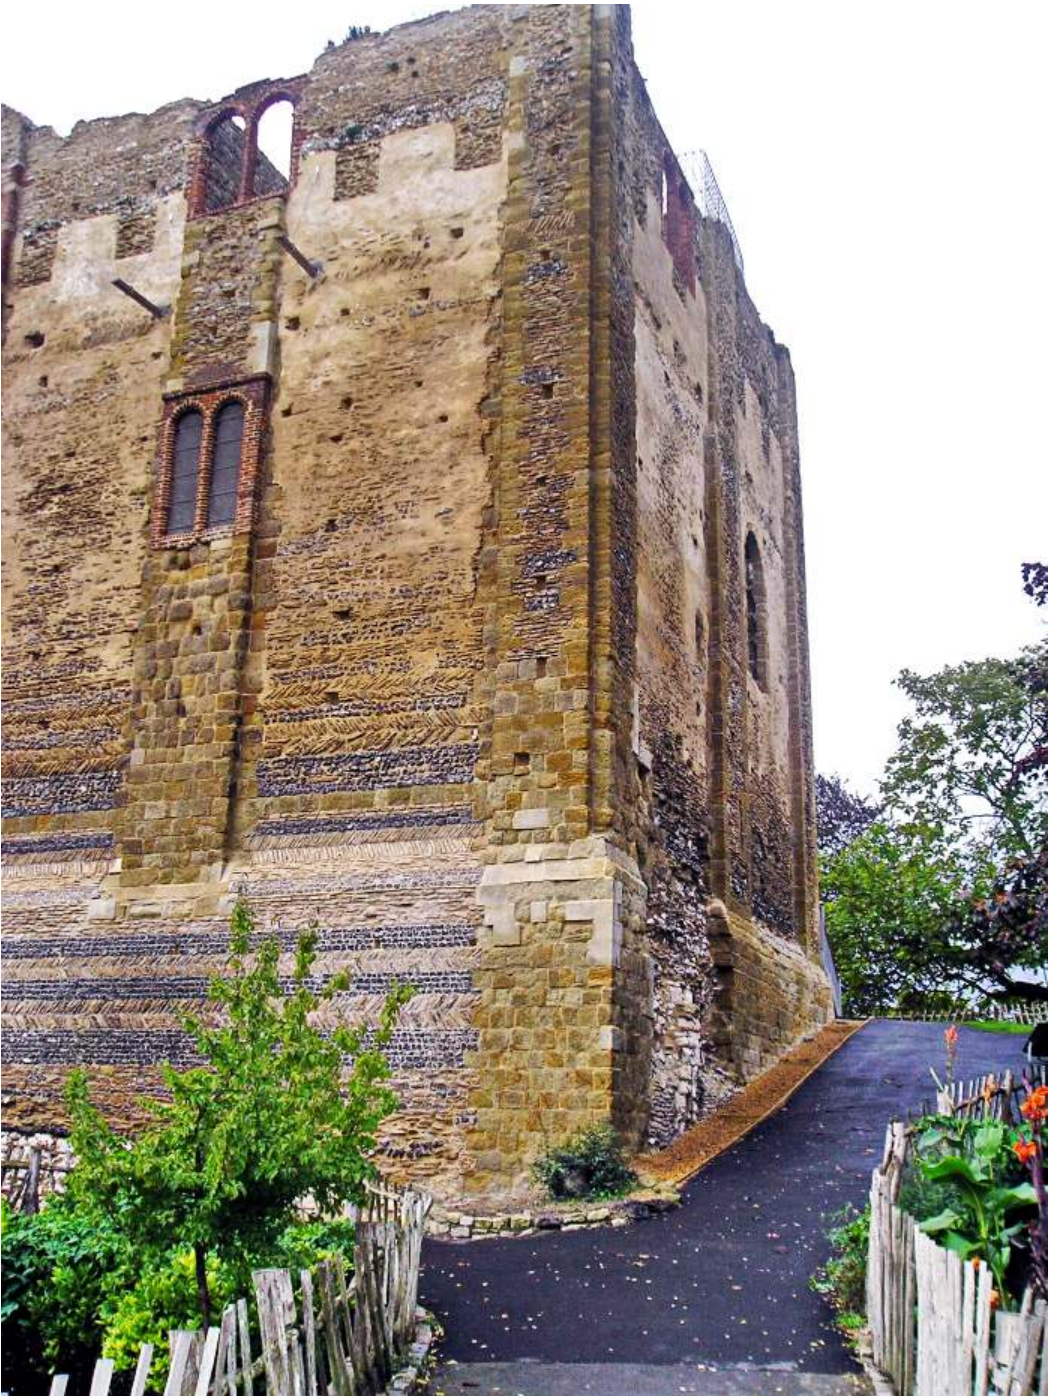
*Fig. 10. The scar on the north wall of the rectangular keep where the shell wall joined. The path follows the line of the original entrance. The east wall of the keep is 10ft lower than the west, The keep entrance is on the west side. The keep was heightened - note the crenellations of the first build, picked out in render.*
